Surveyor Name	GCK	Certificate Number	U-210-10171
Owner		Customer	
Drainage Area	TC4	PO Number	1618
Pipe Segment Reference	TC4-M12-2 to TC4-M12-3	Date	12/29/2008 08:28
Street	Vincent St	City	City of POSM
Comments

Project: TC4

Pipe Segment Reference: TC4-M12-2 to TC4-M12-3

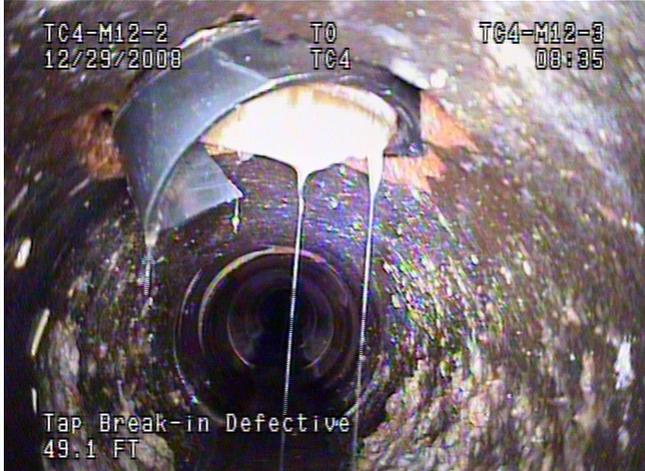
Distance	Fault Observation	Time	Picture
49.1	<p>Tap Break-in/Hammer Defective Position: 12 Severity: None Size: 4 Percent: 0 Maint Weight: 3</p>	00:04:32

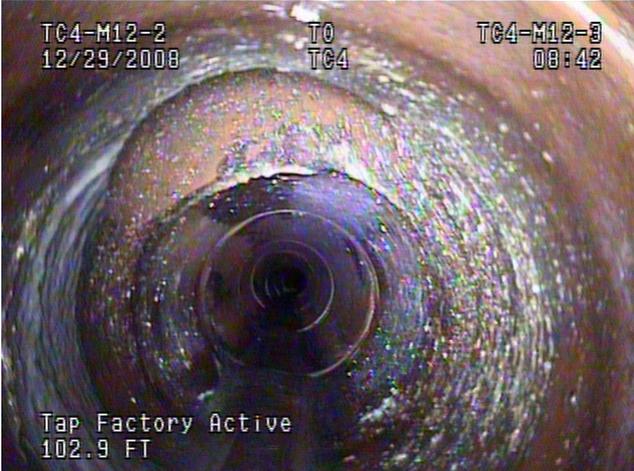
Distance	Fault Observation	Time	Picture
102.9	Tap Factory Activity Position: 11 Severity: None Size: 6 Percent: 0	00:11:05

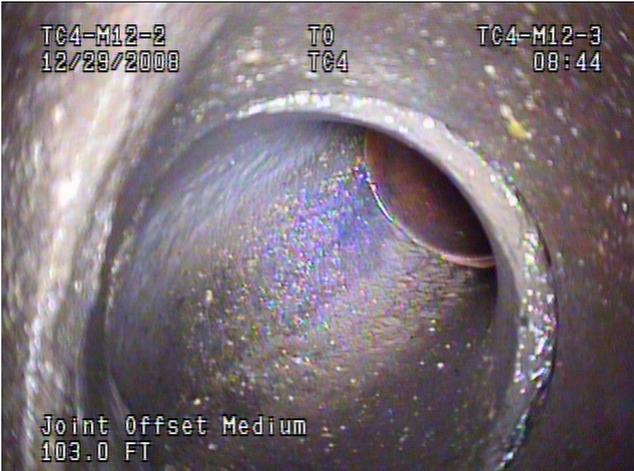
103.0	Joint Offset Medium Severity: None Percent: 0 Remarks: IN LAT N/L Struct Weight: 1	00:12:59

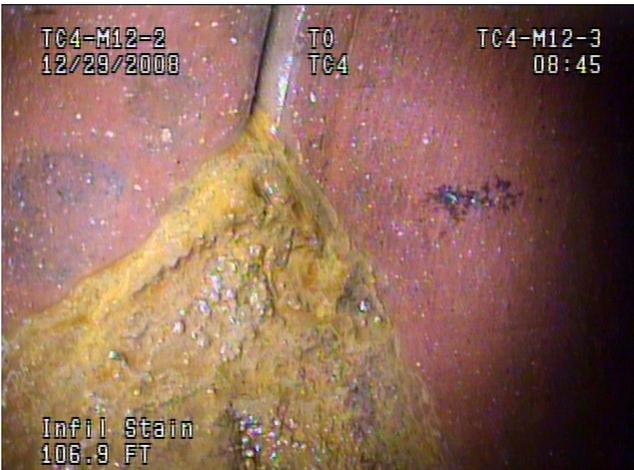
106.9	Infiltration Stain Position: 9 Severity: None Percent: 0 Joint	00:14:01

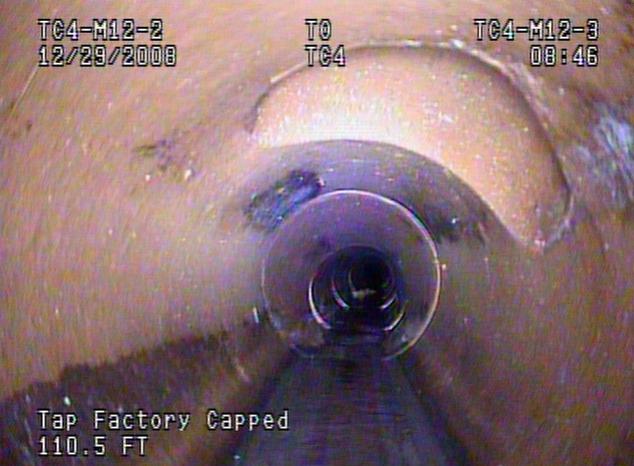
Distance	Fault Observation	Time	Picture
110.5	Tap Factory Capped Position: 1 Severity: None Size: 6 Percent: 0 Remarks: N/L	00:15:33

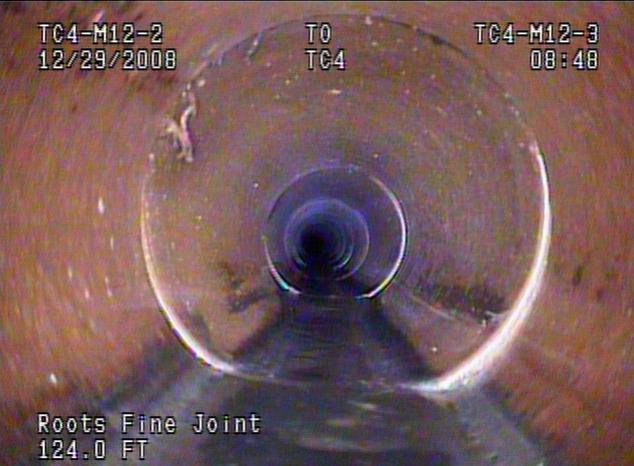
124.0	Roots Fine Joint Position: 9 To 2 Severity: None Percent: 0 Joint Maint Weight: 1	00:17:01

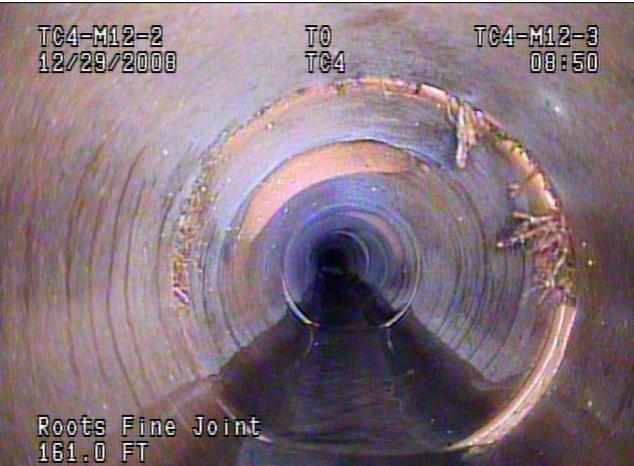
161.0	Roots Fine Joint Position: 8 To 4 Severity: None Percent: 0 Joint Maint Weight: 1	00:19:13

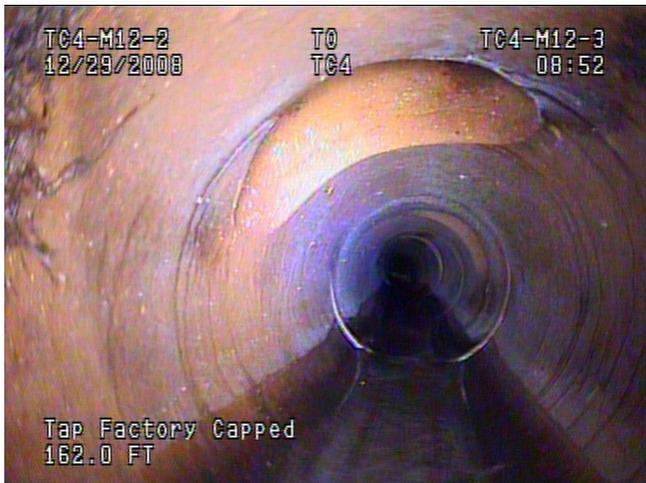
Distance	Fault Observation	Time	Picture
162.0	Tap Factory Capped Position: 11 Severity: None Size: 6 Percent: 0 Remarks: N/L	00:20:52

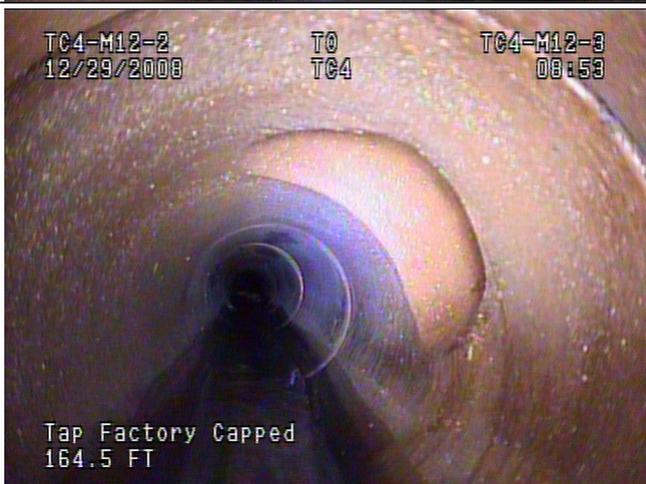
164.5	Tap Factory Capped Position: 2 Severity: None Size: 6 Percent: 0 Remarks: N/L	00:22:41

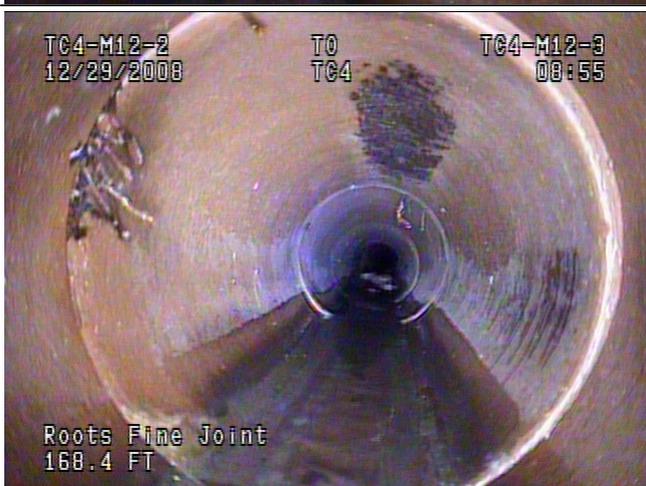
168.4	Roots Fine Joint Position: 9 To 1 Severity: None Joint Maint Weight: 1	00:24:18

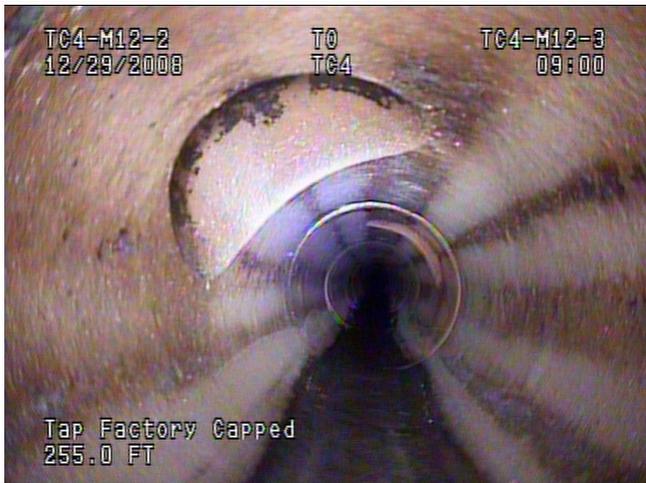
Distance	Fault Observation	Time	Picture
255.0	Tap Factory Capped Position: 11 Severity: None Size: 6 Percent: 0 Remarks: N/L	00:29:08

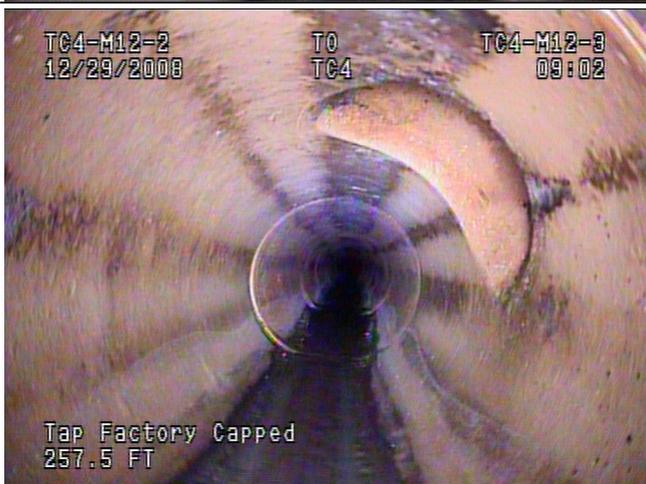
257.5	Tap Factory Capped Position: 2 Severity: None Size: 6 Percent: 0 Remarks: N/L	00:30:55

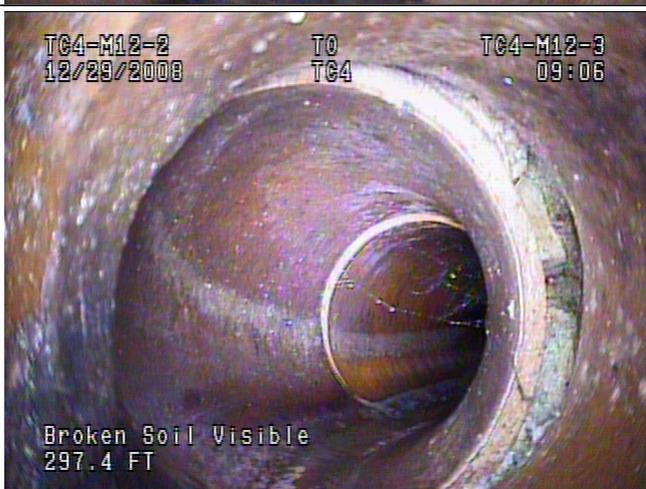
297.4	Broken Soil Visible Position: 9 Severity: None Percent: 0 Joint Remarks: LATERAL Struct Weight: 5	00:35:08

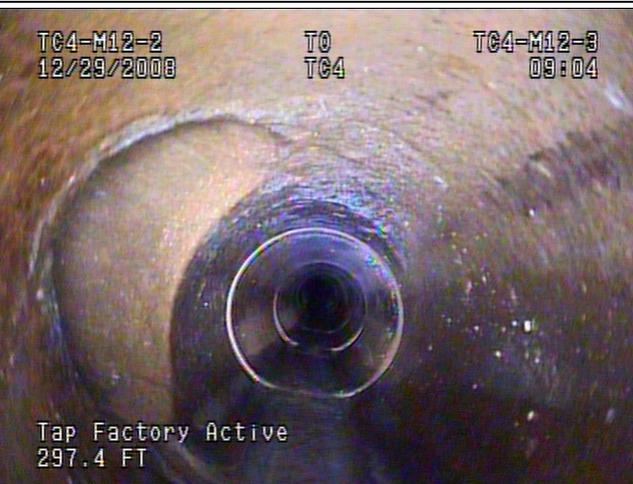
Distance	Fault Observation	Time	Picture
297.4	Tap Factory Activity Position: 9 Severity: None Size: 6 Percent: 0	00:33:14

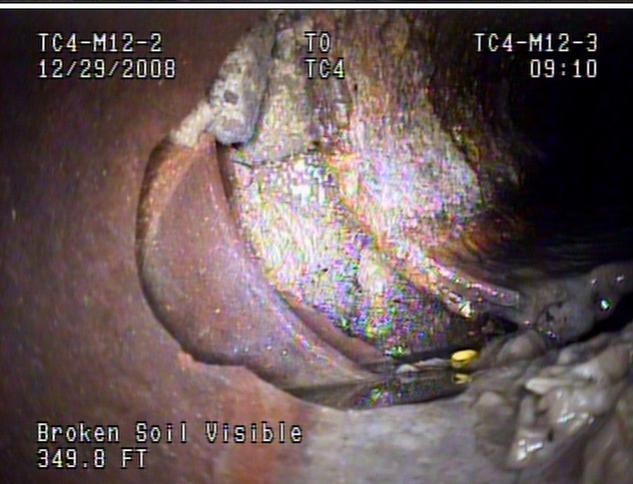
349.8	Broken Soil Visible Position: 3 Severity: None Percent: 0 Joint Remarks: LATERAL Struct Weight: 5	00:39:32

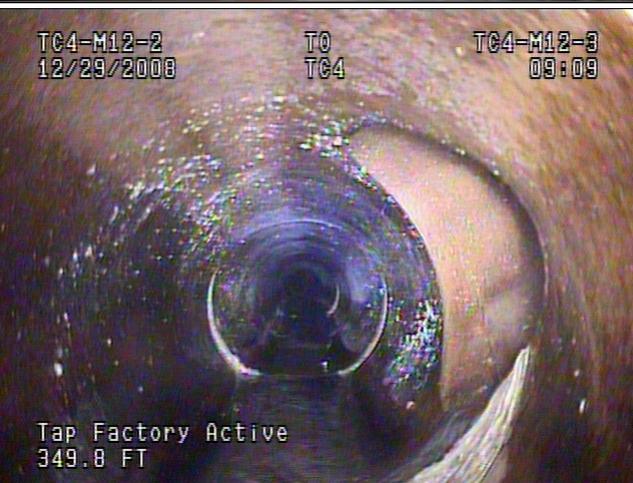
349.8	Tap Factory Activity Position: 3 Severity: None Size: 6 Percent: 0 Remarks: N/L	00:38:26

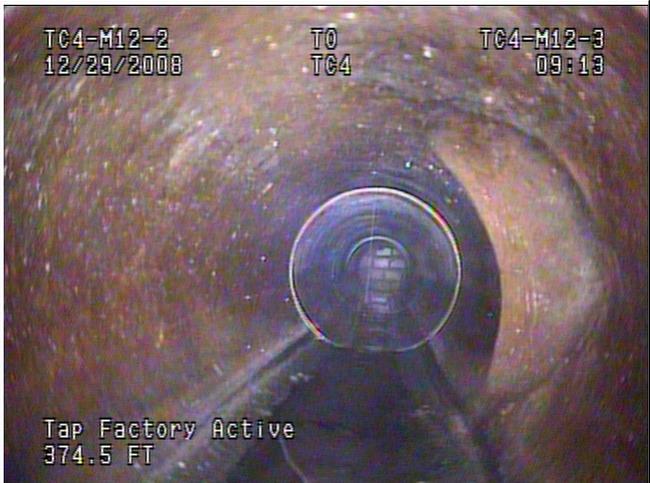
Distance	Fault Observation	Time	Picture
374.5	<p>Tap Factory Activity Position: 3 Severity: None Size: 6 Percent: 0</p>	00:41:56

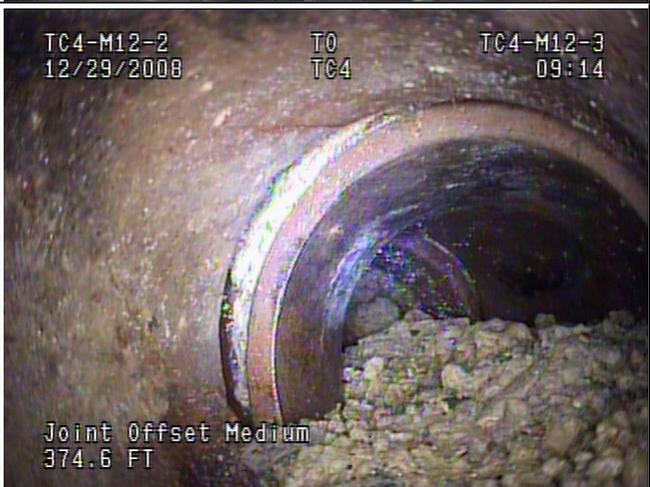
374.6	<p>Joint Offset Medium Severity: None Percent: 0 Remarks: POSS BROKE LAT Struct Weight: 1</p>	00:43:07
